# Utility Trailer Condition Report

| Field | Value |
|---|---|
| Trailer | 2009 TFMC utility trailer - white - VIN last 4: 6255 |

Owner-supplied condition report for a white 2009 TFMC utility trailer, VIN ending 6255. Compiled on 2026-10-07 from owner statements and 13 photos; the physical inspection date was not supplied. Exterior wear, side and rear door damage, undercarriage rust and older tires need follow-up. Owner reports tire pressure was corrected and outlets and lights work. Repair door and hinge damage, assess rust and replace older tires. Verify repairs and operation before further use.

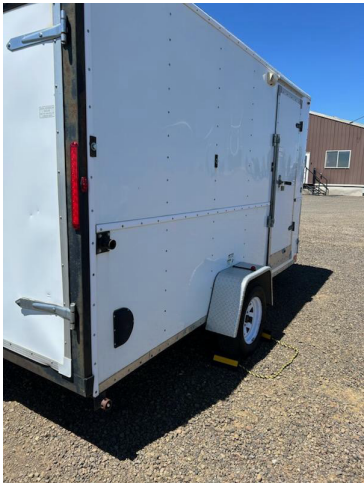
| Item | Status | Notes |
|---|---|---|
| Exterior wear and body panels | NEEDS ATTENTION | Exterior panels show dents, dings and surface wear. Owner reports accumulated wear over the years. Four overview photos document the white utility trailer; individual door damage is recorded separately. |

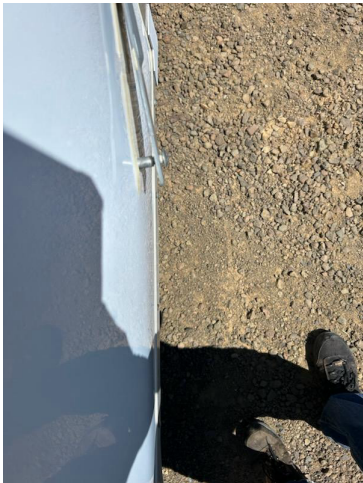
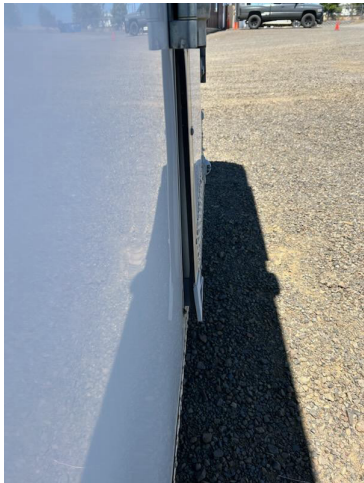
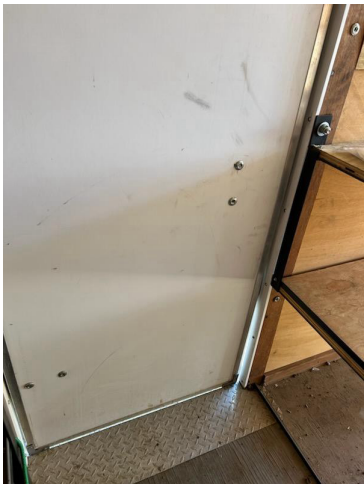
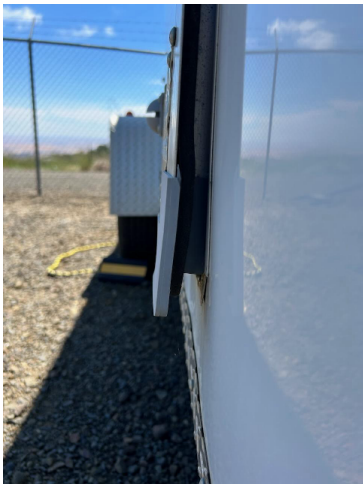
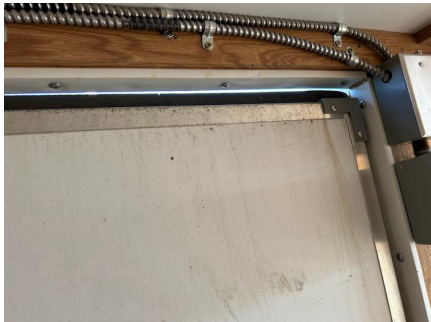
| Item | Status | Notes |
|---|---|---|
| Side door and hinges | NEEDS ATTENTION | Owner reports attempted forced entry at the side door, leaving bent door material and broken hinges. Photos show door-edge distortion and gaps. Repair the door and damaged hinge hardware, then check alignment, secure latching and closure. |

Section Summary: Exterior wear is documented in the overview photos. Owner-reported forced-entry damage at the side and rear doors remains open for repair. Verify secure latching and closure after repairing damaged doors and hinge hardware.

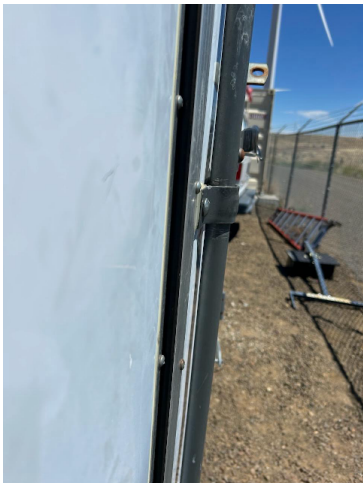
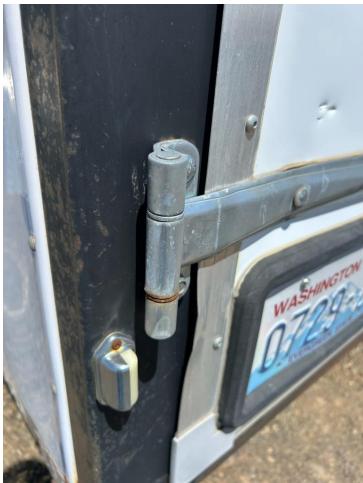
| Item | Status | Notes |
|---|---|---|
| Rear doors and locking hardware | NEEDS ATTENTION | Owner reports attempted forced entry at the rear, with bent doors and broken hinge hardware. Close-up photos document the rear door and locking-bar areas. Inspect and repair the damaged hardware, then verify door alignment, latching and secure closure. |

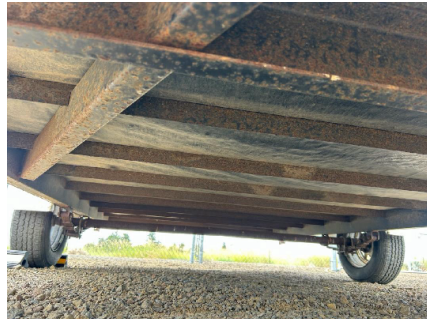
| Item | Status | Notes |
|---|---|---|
| Undercarriage surface rust | NEEDS ATTENTION | The undercarriage photo shows surface rust on visible steel members. Owner also reports surface rust. Have the frame and running gear inspected to determine whether cleaning, treatment or repairs are needed; a photo alone does not establish structural condition. |
