## Columbia Trailer Inspections

# Utility Trailer Condition Report

| Field | Value |
|---|---|
| Trailer | 2009 TFMC utility trailer - white - VIN last 4: 6255 |

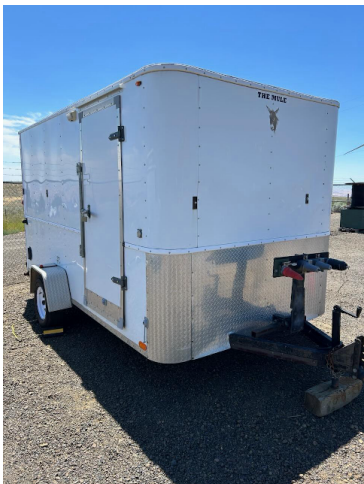
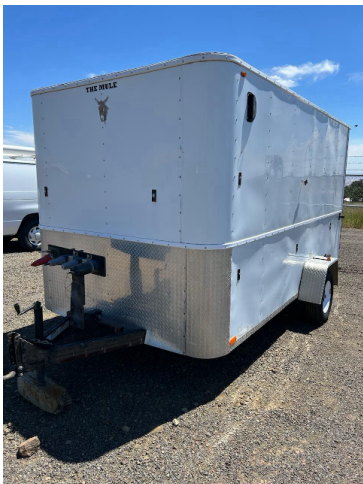
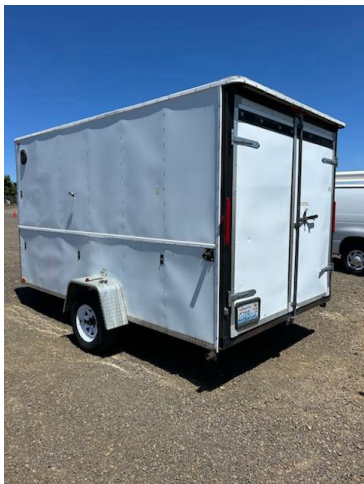
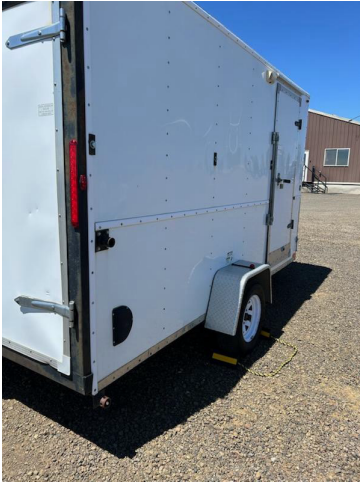
| Item | Status | Notes |
|---|---|---|
| Exterior wear and body panels | NEEDS ATTENTION | Exterior panels show dents, dings and surface wear. Owner reports accumulated wear over the years. Four overview photos document the white utility trailer; individual door damage is recorded separately. |

Exterior wear and body panels

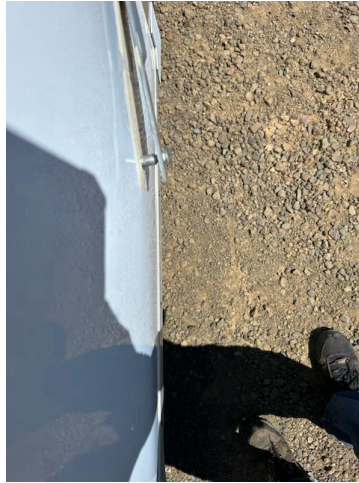
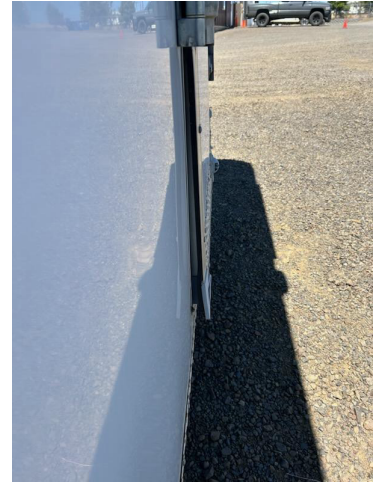
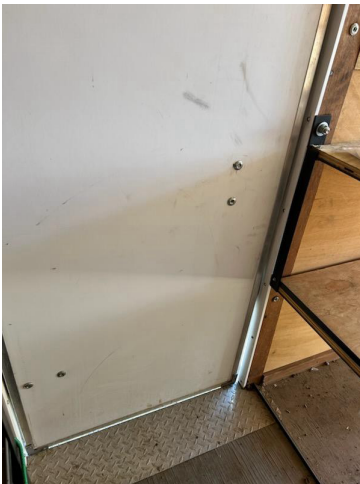
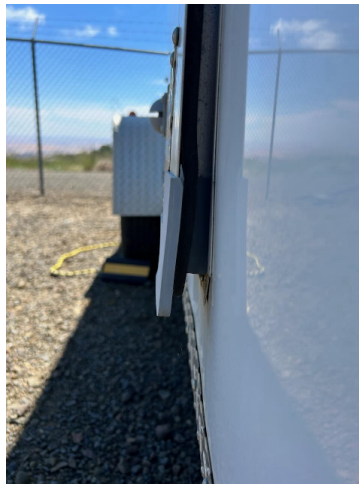
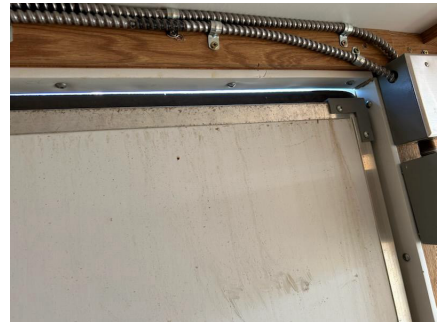
| Item | Status | Notes |
|---|---|---|
| Side door and hinges | NEEDS ATTENTION | Owner reports attempted forced entry at the side door, leaving bent door material and broken hinges. Photos show door-edge distortion and gaps. Repair the door and damaged hinge hardware, then check alignment, secure latching and closure. |

Side door and hinges

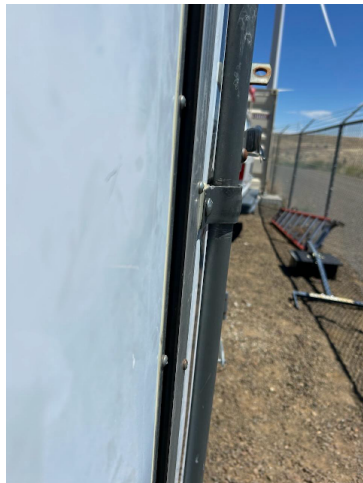
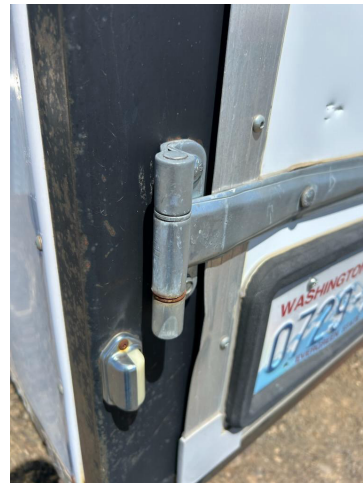
| Item | Status | Notes |
|---|---|---|
| Rear doors and locking hardware | NEEDS ATTENTION | Owner reports attempted forced entry at the rear, with bent doors and broken hinge hardware. Close-up photos document the rear door and locking-bar areas. Inspect and repair the damaged hardware, then verify door alignment, latching and secure closure. |

Rear doors and locking hardware

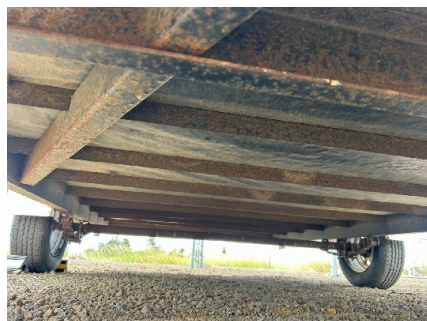
| Item | Status | Notes |
|---|---|---|
| Undercarriage surface rust | NEEDS ATTENTION | The undercarriage photo shows surface rust on visible steel members. Owner also reports surface rust. Have the frame and running gear inspected to determine whether cleaning, treatment or repairs are needed; a photo alone does not establish structural condition. |

Undercarriage surface rust

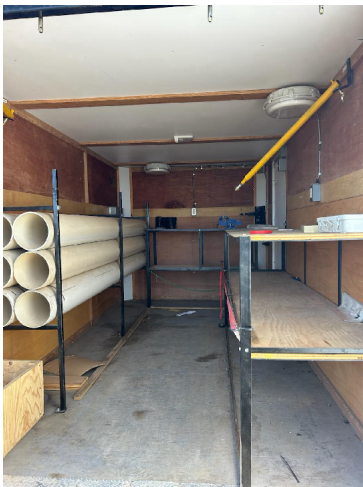
| Item | Response | Notes |
|---|---|---|
| Interior lights working | Yes | Owner reports the interior lights are working. The attached interior photo records shelving, work surfaces and visible floor wear as a reference view; it does not prove an energized light test. |

Interior lights working
